A LABOUR OF LOVE

David Bowers meets a restored Series IIA that's had the benefit of serious attention to detail

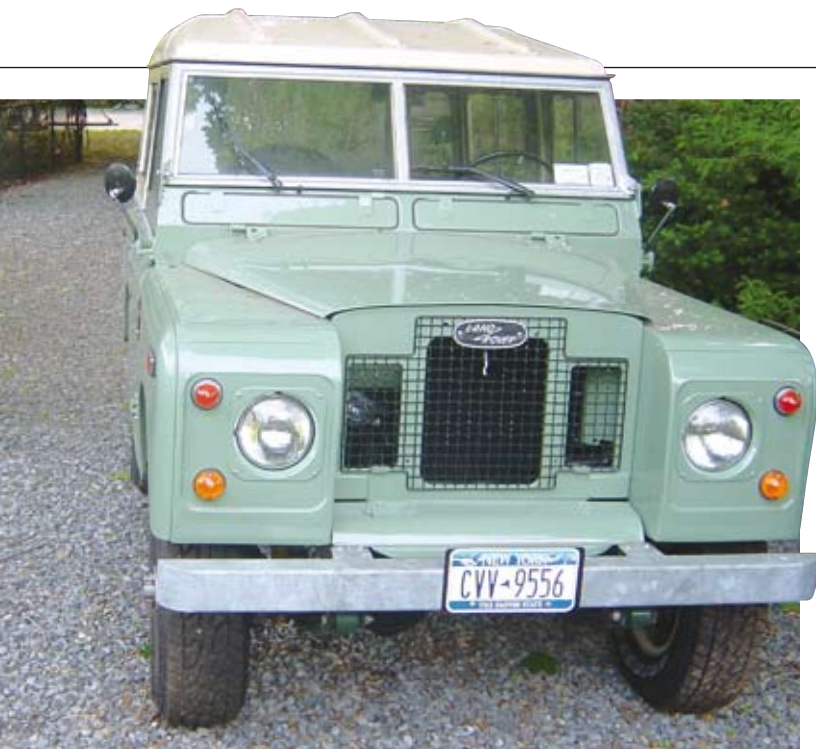
Left: Michael Williams admired the uncomplicated Series IIA for many years before the opportunity arrived to own it himself. Below: A neat reversing light. Below left: Dashboard scene of high drama when wiring 'harness' burnt out due to a short circuit – lots of fuses later added. Below right: Chequer plate makes the rear tub smart and tough.

"I wanted to show the car that weekend, so I hurriedly fitted a PVC replacement harness, but adding lots more fuses for extra safety and to avoid seeing smoke pouring out of the dash again. I fused each of the ignition wires inside the dash, also the dash lighting and interior roof light. However, the Lucas fuse box still looks original, as we added an extra fuse box to accommodate additional wiring."

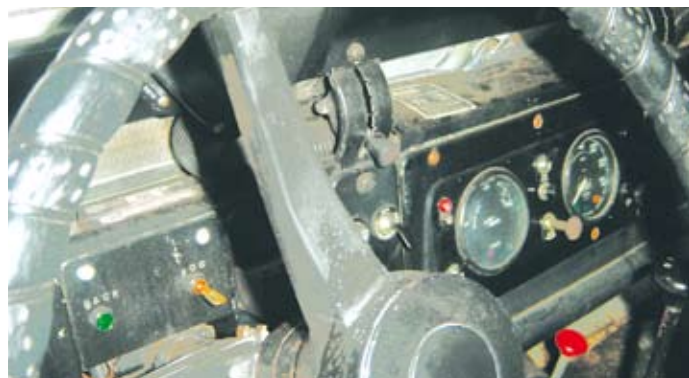
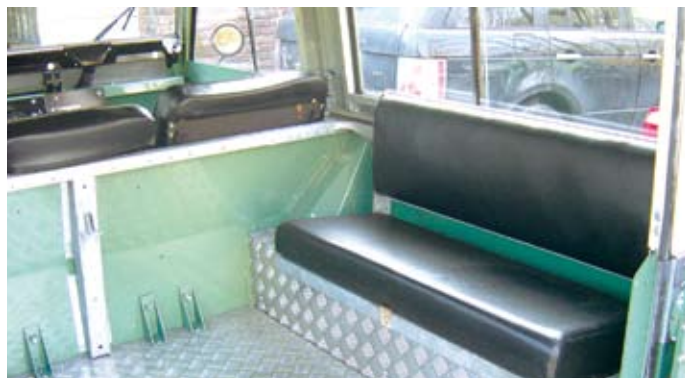
Top, left to right: New chassis with original running gear installed; Sills removed and body awaits new doorposts; Original paint removed using stripper solution used in aviation industry. Below left and right: Condition of engine bay suggested a hard life; Rigorous detailing/cleaning allowed for neater appearance.

chassis was a bit of a morale boost, although the condition of the fully exposed chassis wasn't encouraging, so it was time to bite the bullet and a replacement was ordered from Atlantic British. This was treated with a high quality, rust resistant paint, POR15, that benefited any other exposed metal surfaces to which salty corrosion from the Atlantic North-East had made its corrosive mark.

A local bodyshop supplied a large quantity of Airplane Stripper, which worked well in liquid form, but not so as an aerosol spray can. Michael added: "You really need to be careful using this stuff by protecting your skin. We used heavy-duty dishwashing gloves, quite literally going through a few. After watching the surface bubble

up, we'd scrape away the paint goo, and then switch to steel wool to scrub away the rest. We also used a dual-action sander with low grit sanding paper, and a wire wheel to get at any spots the stripper couldn't affect."

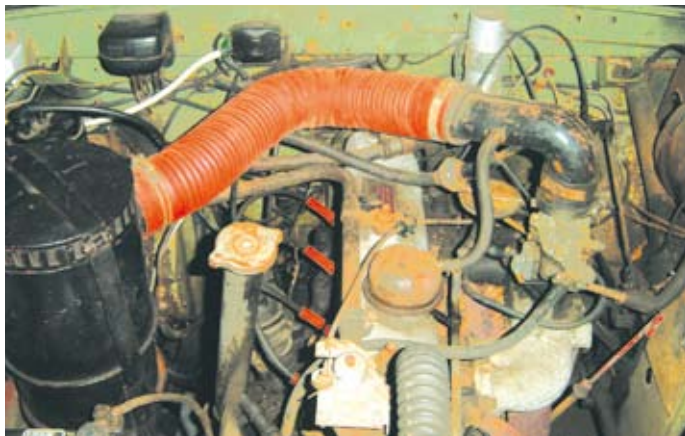
Left: Removing the rear crossmember called for a heavy-duty electric drill, a steady hand and a strong back before the job was all done and dusted.

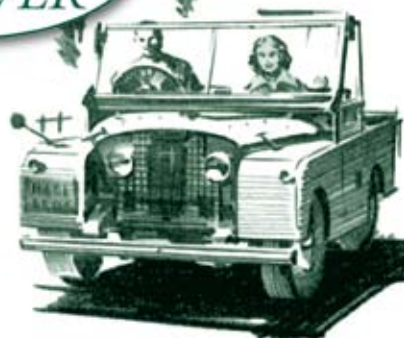
Below: Meticulous attention to detail allowed the galvanized trim to be re-used using the manufacturer's original techniques.

The same procedure was adopted for the galvanized trim, which had been painted over. Getting the trim off the vehicle so each section could be re-galvanized was achieved with a hammer and chisel. An air tool knocked off the remaining part of the rivet beneath the load bed. The removed galvanized trim was then thoroughly cleaned and sent away to be re-galvanized. It was replaced using rivets and hardware tools supplied by Jim Dix's Big Flats Rivet Company. Michael explained the refitting technique he used: "Not sure whether this was necessary, but I lowered my compressor's air pressure, as some of my early test results were a mess. I asked someone to hold a large bucking bar against the head of the rivet

- flat against the outside body, and then I hit the inside end of the rivet with the air tool a few times, creating a rounded head on the inside and that's all there was to it!" Round-headed, 3/16th aluminium rivets were used in two lengths, the shorter type being used for most applications, and the longer ones, after cutting down to the appropriate size, for where galvanized trim had been folded over.
